**Guaranteed
Property
Inspections**

Inspection Report

Property Address:
123 St.

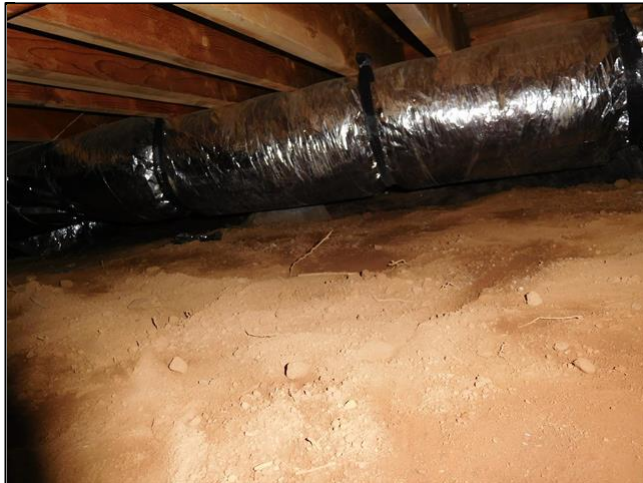
2.1 Item 1(Picture) Earth floor

(1) Earth floor, this condition can degrade indoor air quality, we recommend an encapsulation system be installed over dried soil, sealing of sub floor openings to the interior (spray polyurethane foam SPF is designed to stop air and moisture intrusion, reduce energy us, strengthen the structure, and protect internal air from mold, and other airborne pollutants.)

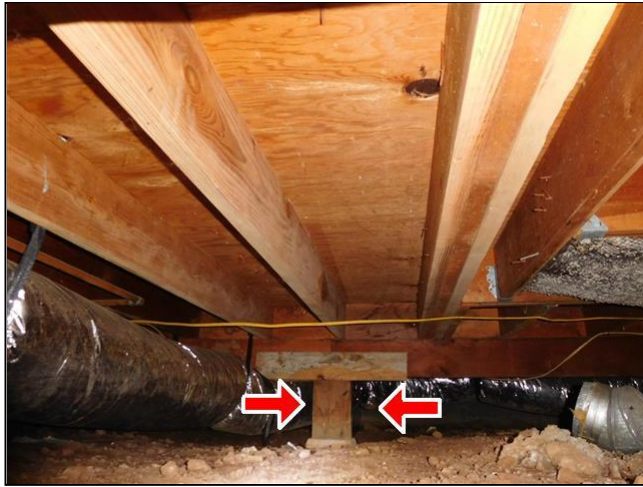
2.1 Item 2(Picture)

(2) Moisture stains of pier indicated historical flooding event or events.

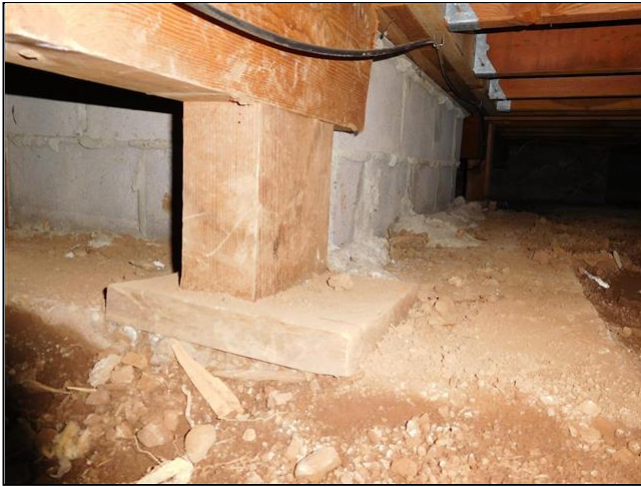
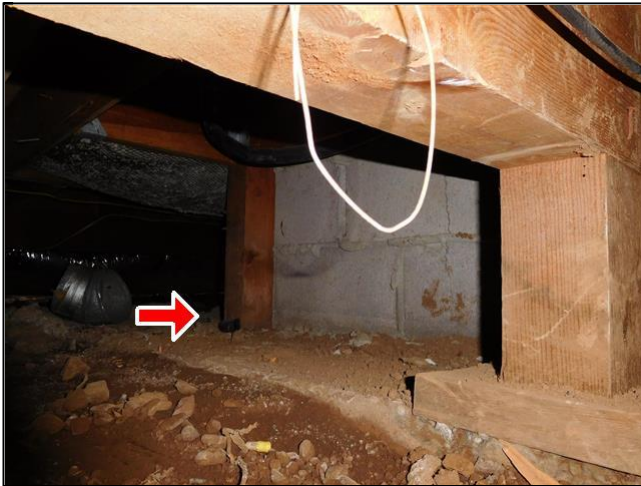
2.8 Item 1(Picture)

(1) Some wood to earth contact.

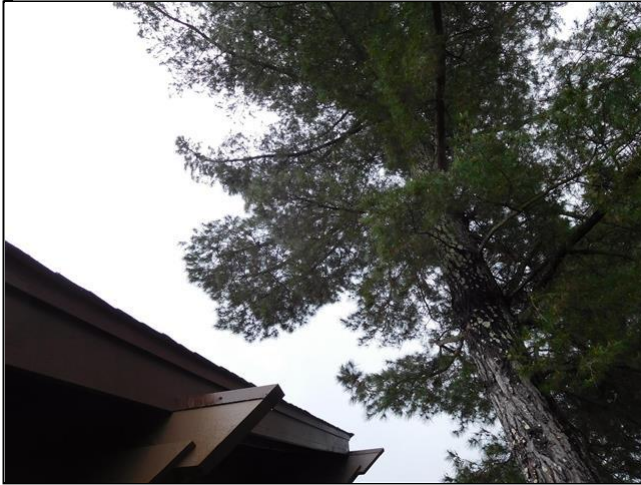
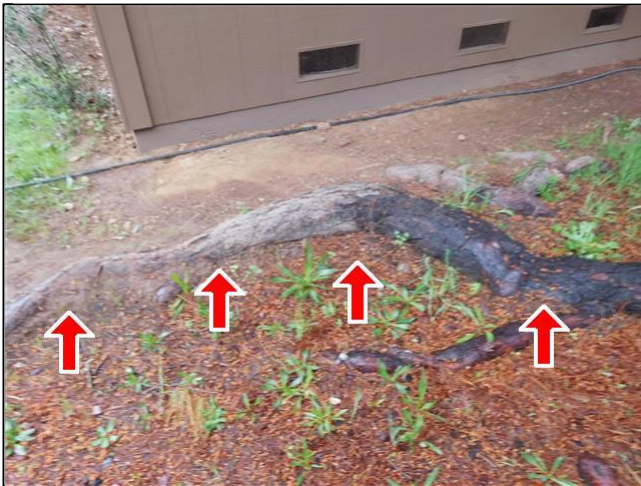
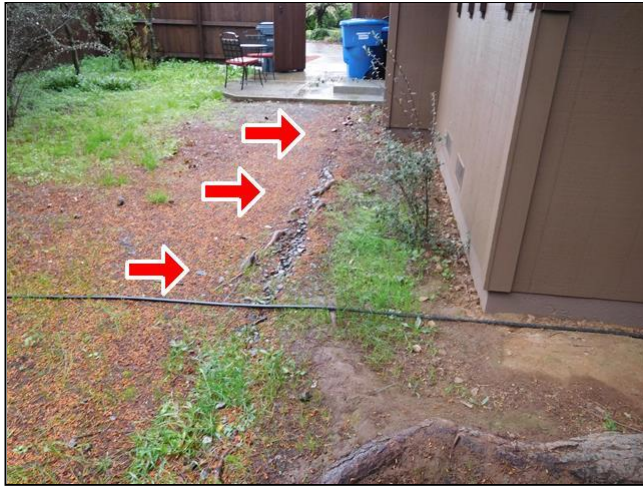
3.15 Item 1(Picture)

(1) Tree branches over roofs, we recommend correction.

Tree roots near structure, we recommend further evaluation to prevent impact on foundation.

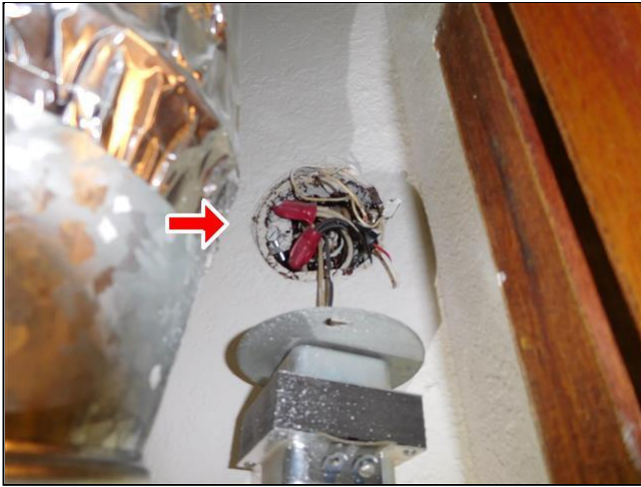
4.8 Item 1(Picture)

(1) Exposed wiring at door bell device in closet, we recommend correction.

EMF testing measured elevated levels above 4.0 milligauss: 1. Left side wall of the shed at the panel adjacent area, we recommend human clearance of 1 ft.; 2. Microwave during use; we recommend clearance of 6 ft. during use; 3. Hallway sub panel; we recommend 1 ft. human clearance; 4. Master bathroom outer wall facing the bedroom across from the sink area; we recommend installation of EMF retarding paint to both sides of the wall, or electrical wiring correction inside the wall by a qualified electrician. This elevation area extended 2 ft. from the wall, and increase when the lights were on in the bathroom.

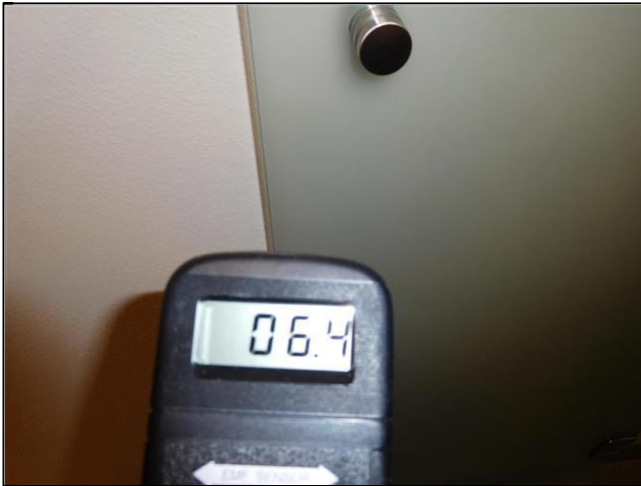
4.8 Item 2(Picture)

(3) Master bath EMF reading.

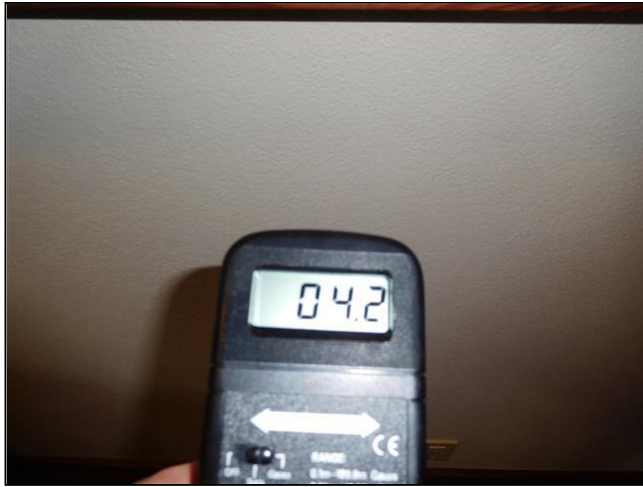
4.8 Item 3(Picture)

(4) EMF reading area of concern.

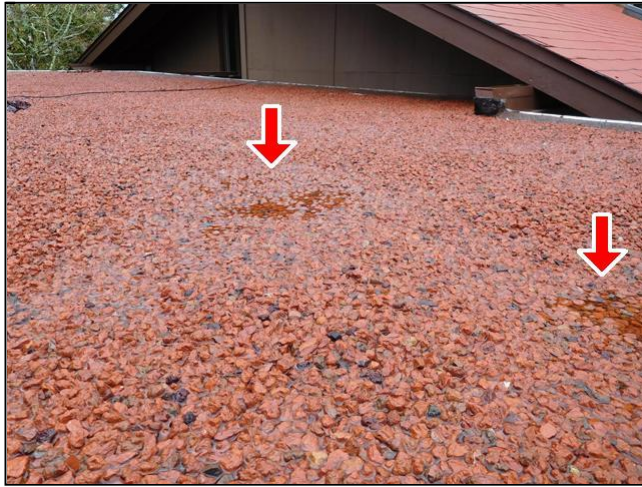
5.0 Item 1(Picture) Ponding

The flat roof had signs of ponding, we recommend further evaluation and correction by a licensed roofer.

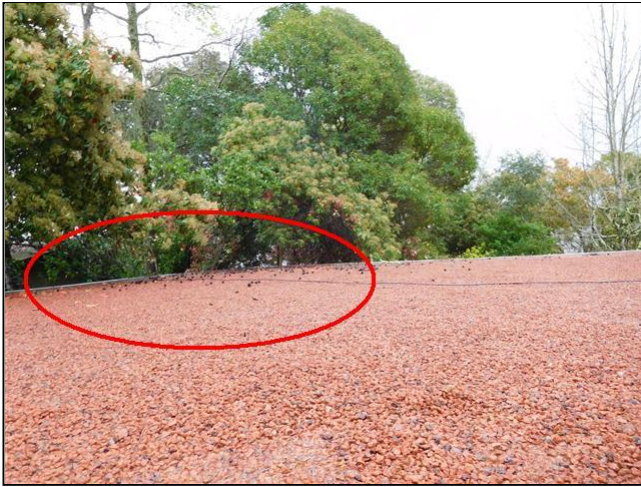
5.0 Item 2(Picture)

(2) Debris on roof, trees over roof.

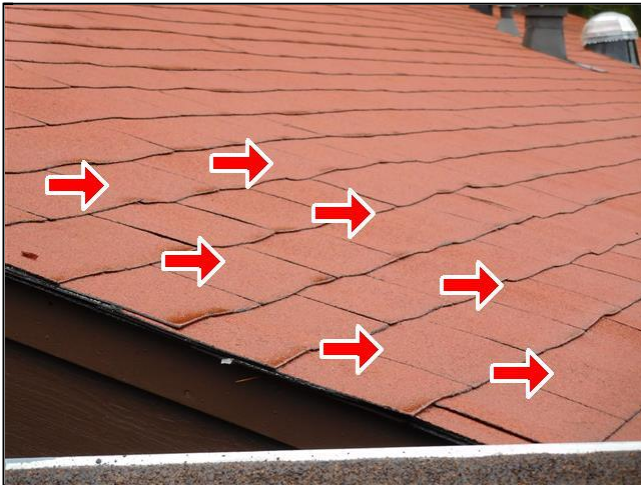
5.0 Item 3(Picture) Buckling

The main roof had buckling near the carport, moisture stains were present in the attic at vent flashings and ridge areas; we recommend a complete roofing system evaluation to determine the need for repair or replacement.

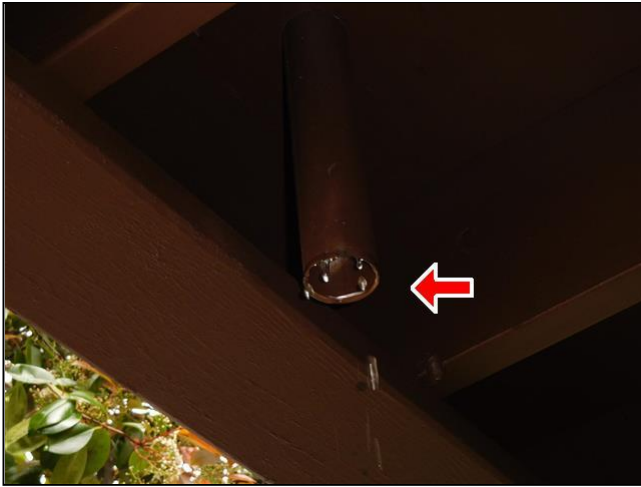
5.4 Item 1(Picture)

Complete gutter and drain line system are needed or erosion or water intrusion can occur.

Missing downspouts at carport roof.

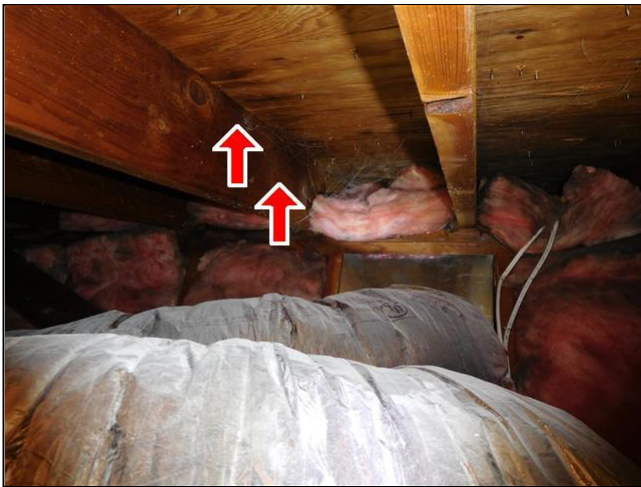
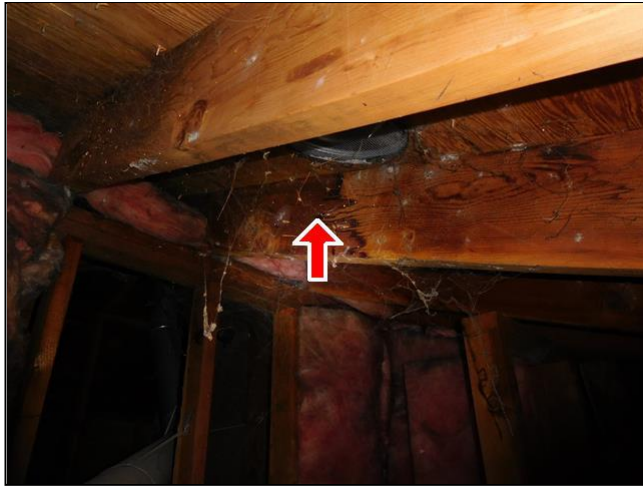
5.6 Item 1(Picture)

(1) Moisture stains, we recommend further evaluation by a roofing contractor and termite professional.

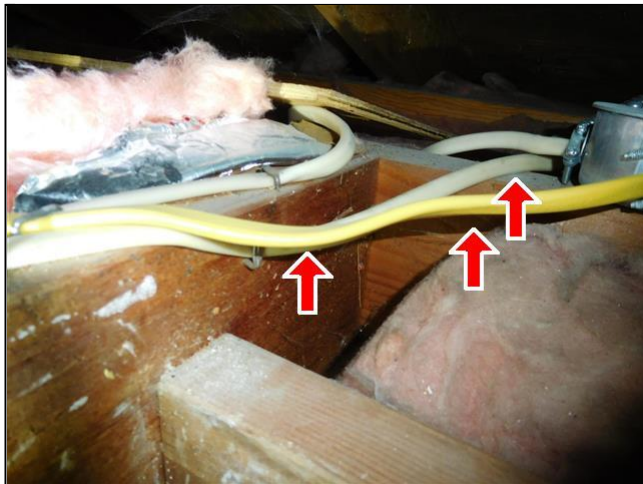
5.10 Item 1(Picture)

Un-protected romex near entry, we recommend correction.

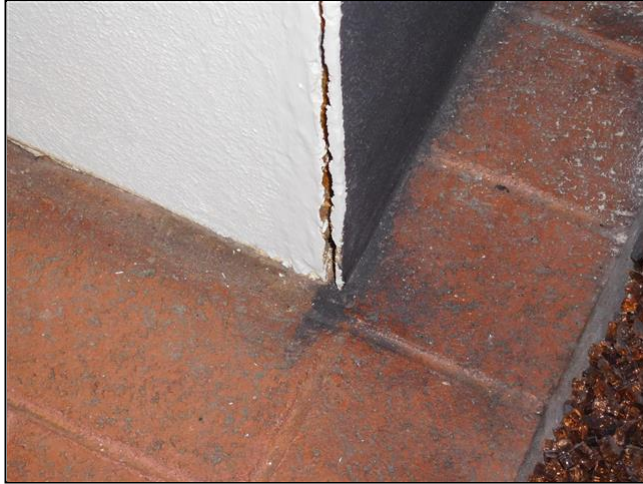
10.13 Item 1(Picture)

(1) Wall damage at left side of the burn chamber, this may be caused by heat, we recommend further evaluation by a chimney sweep.

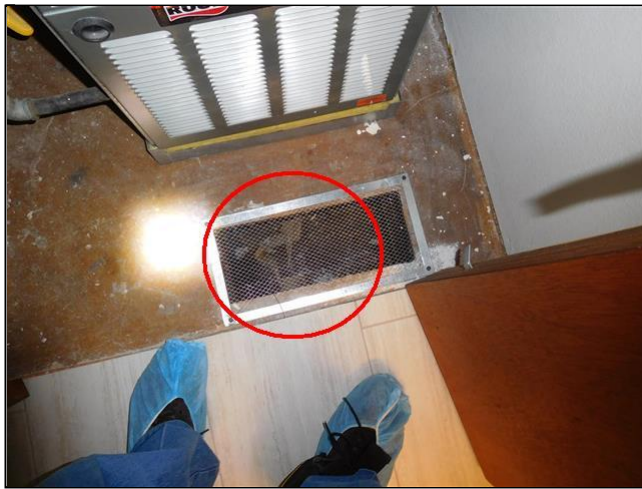
13.0 Item 1(Picture)

Crawl space microbial malodors entered the laundry area at a vent opening. We conducted an ERMI mold test for mold burden. Results are expected by Friday.

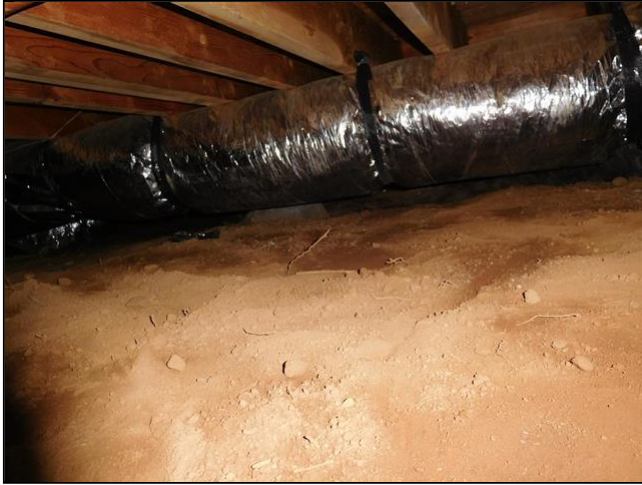
2.1 Item 1(Picture) Earth floor

(1) Earth floor, this condition can degrade indoor air quality, we recommend an encapsulation system be installed over dried soil, sealing of sub floor openings to the interior (spray polyurethane foam SPF is designed to stop air and moisture intrusion, reduce energy us, strengthen the structure, and protect internal air from mold, and other airborne pollutants.)

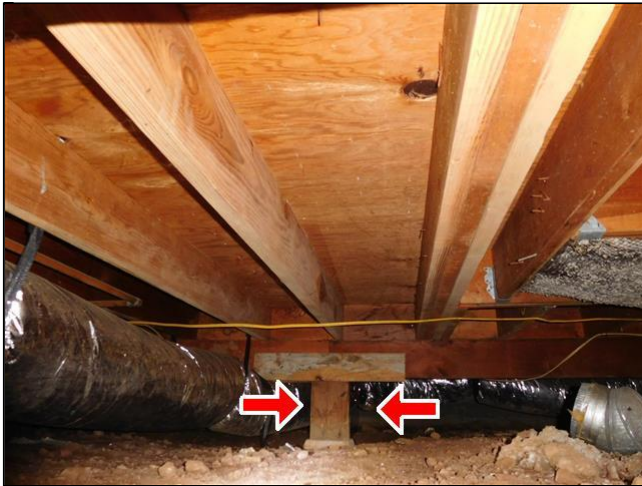
2.1 Item 2(Picture)

(2) Moisture stains of pier indicated historical flooding event or events.

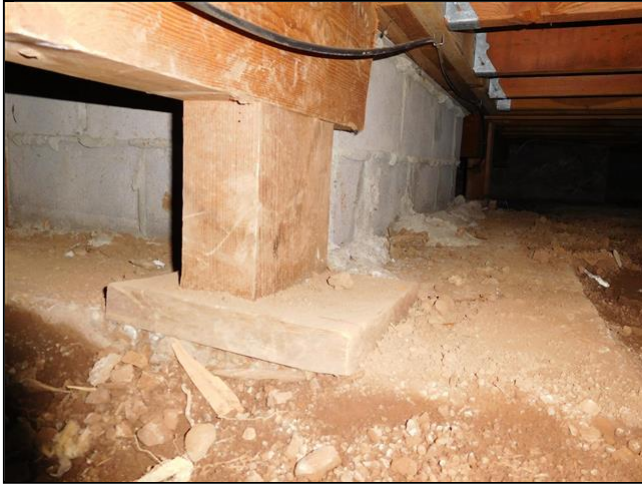
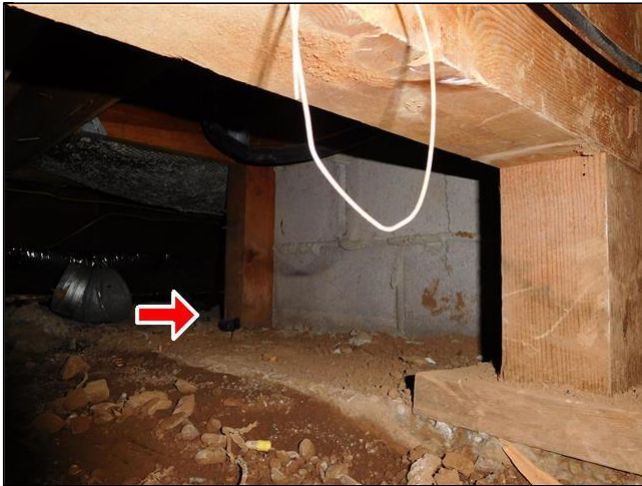
2.8 Item 1(Picture)

(1) Some wood to earth contact.

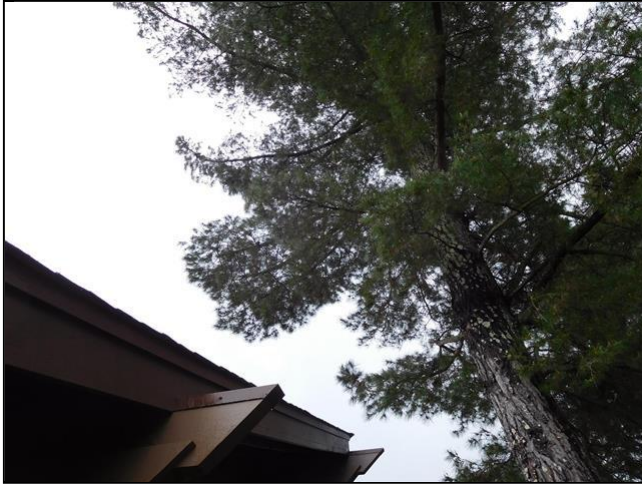
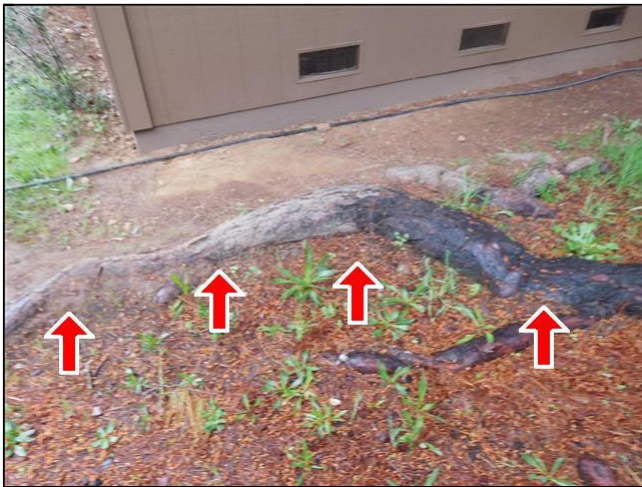
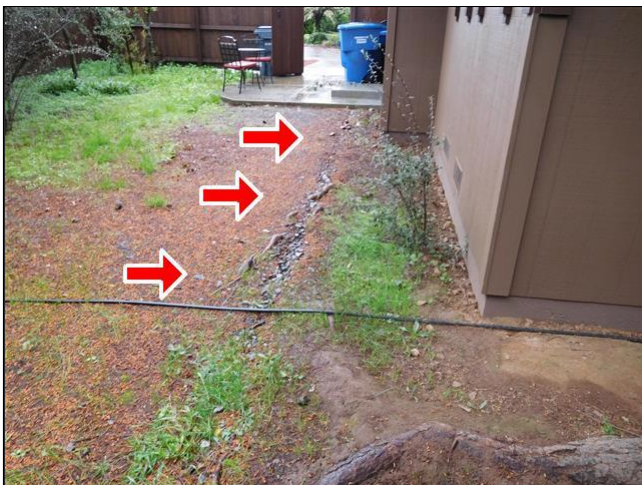
3.15 Item 1(Picture)

(1) Tree branches over roofs, we recommend correction.

Tree roots near structure, we recommend further evaluation to prevent impact on foundation.

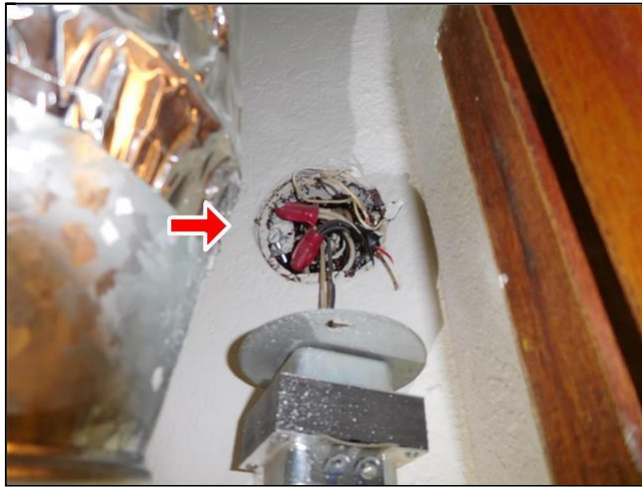
4.8 Item 1(Picture)

(1) Exposed wiring at door bell device in closet, we recommend correction.

EMF testing measured elevated levels above 4.0 milligauss: 1. Left side wall of the shed at the panel adjacent area, we recommend human clearance of 1 ft.; 2. Microwave during use; we recommend clearance of 6 ft. during use; 3. Hallway sub panel; we recommend 1 ft. human clearance; 4. Master bathroom outer wall facing the bedroom across from the sink area; we recommend installation of EMF retarding paint to both sides of the wall, or electrical wiring correction inside the wall by a qualified electrician. This elevation area extended 2 ft. from the wall, and increase when the lights were on in the bathroom.

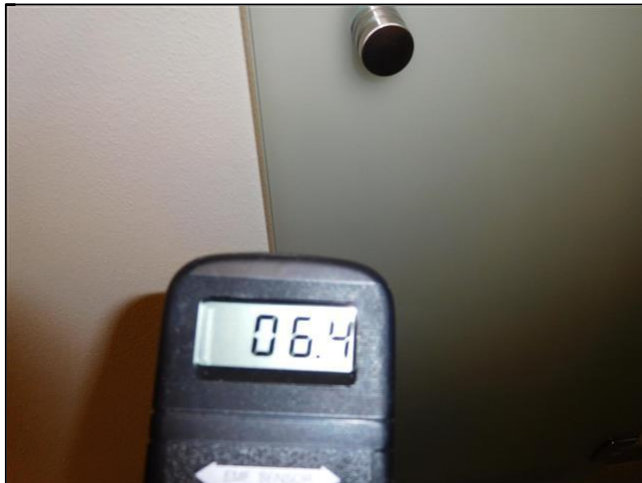
4.8 Item 2(Picture)

(3) Master bath EMF reading.

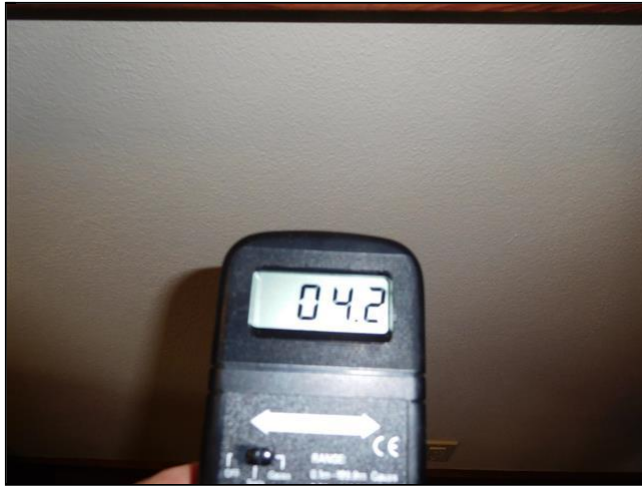
4.8 Item 3(Picture)

(4) EMF reading area of concern.

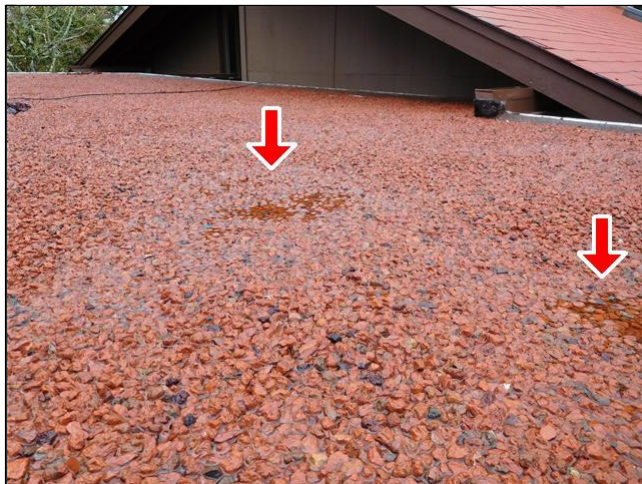
5.0 Item 1(Picture) Ponding

The flat roof had signs of ponding, we recommend further evaluation and correction by a licensed roofer.

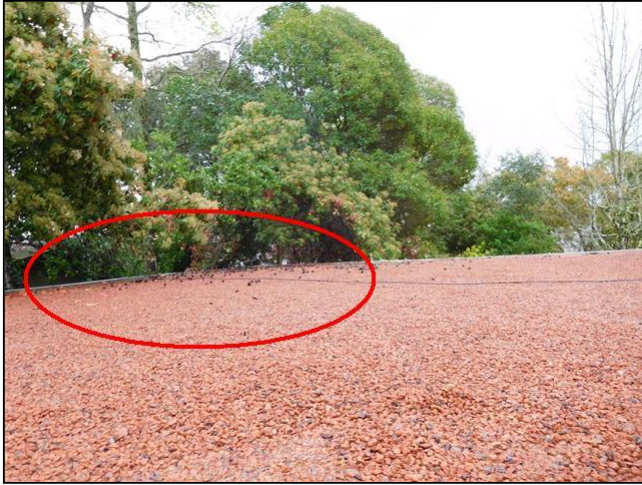
5.0 Item 2(Picture)

(2) Debris on roof, trees over roof.

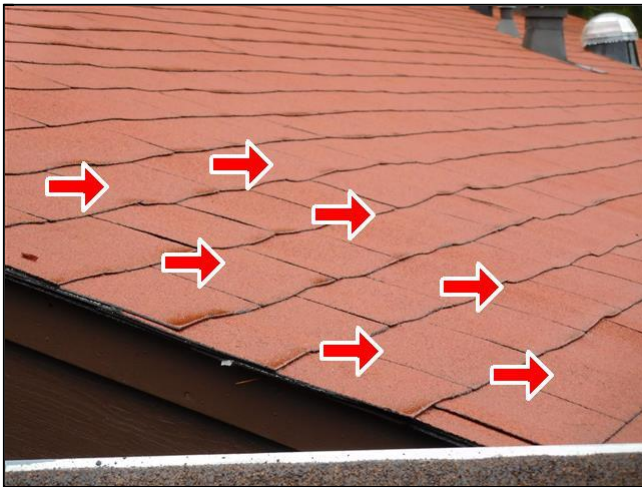
5.0 Item 3(Picture) Buckling

The main roof had buckling near the carport, moisture stains were present in the attic at vent flashings and ridge areas; we recommend a complete roofing system evaluation to determine the need for repair or replacement.

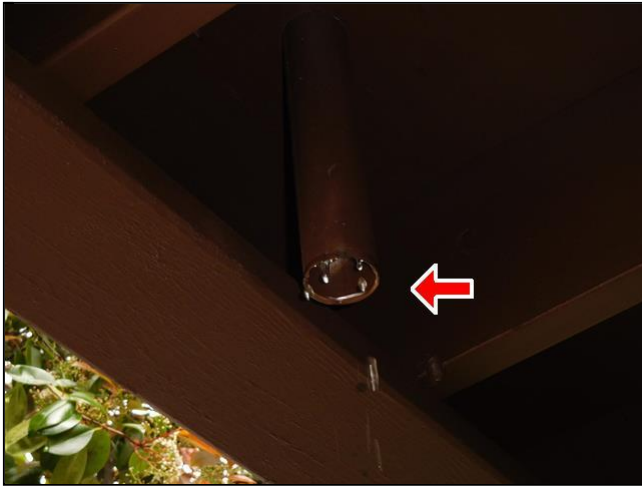
5.4 Item 1(Picture)

Missing downspouts at carport roof.

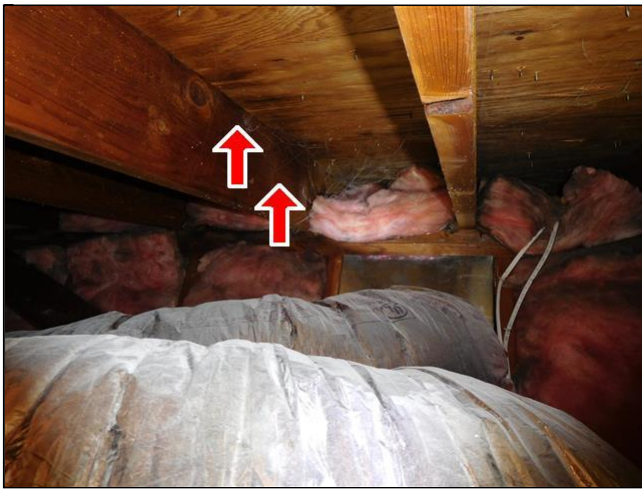
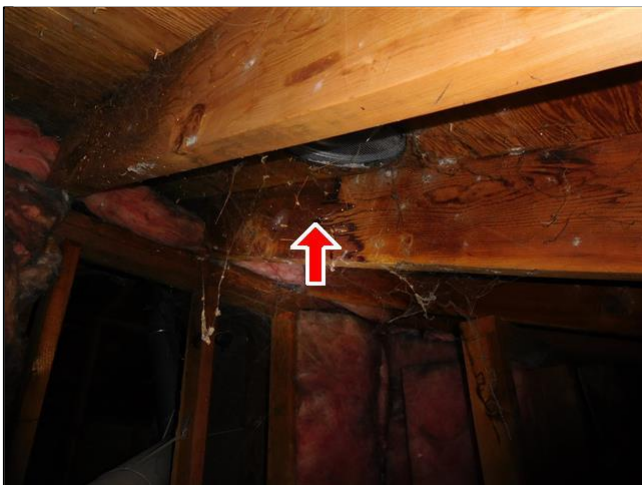
5.6 Item 1(Picture)

(1) Moisture stains, we recommend further evaluation by a roofing contractor and termite professional.

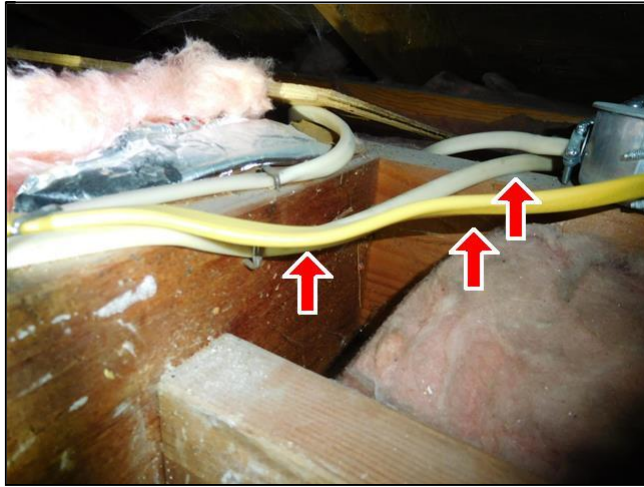
5.10 Item 1(Picture)

Un-protected romex near entry, we recommend correction.

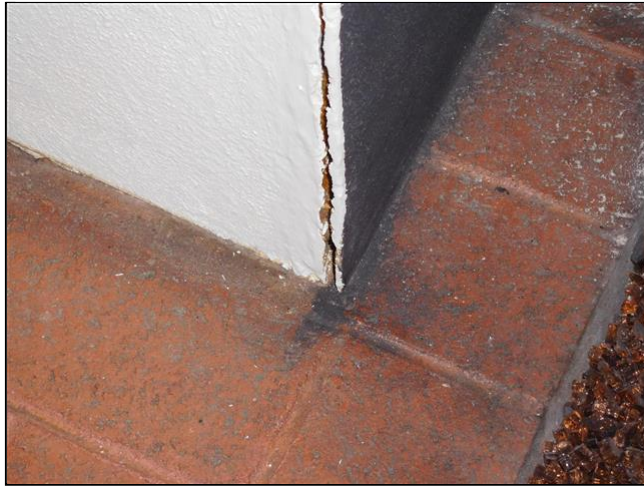
10.13 Item 1(Picture)

(1) Wall damage at left side of the burn chamber, this may be caused by heat, we recommend further evaluation by a chimney sweep.

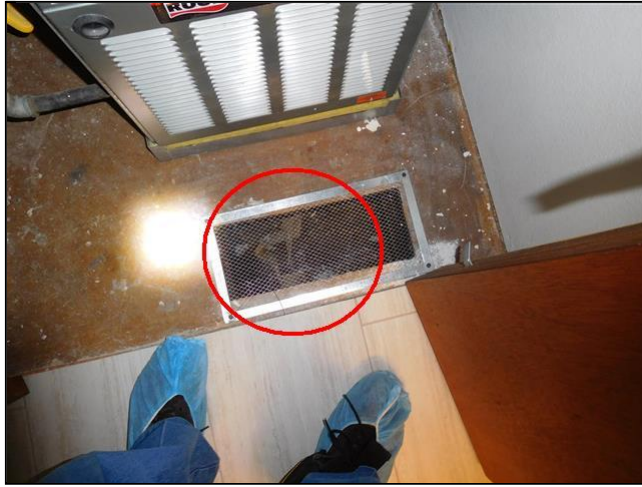
13.0 Item 1(Picture)

Crawl space microbial malodors entered the laundry area at a vent opening. We conducted an ERMI mold test for mold burden. Results are expected by Friday.
